# Manhole Inspection Summary

Manhole # S23GG2035MH

**Inspection** ☐ Is Incomplete Rating: **3) Fair**

**Location** Address: **5602 WAYCREST LN**

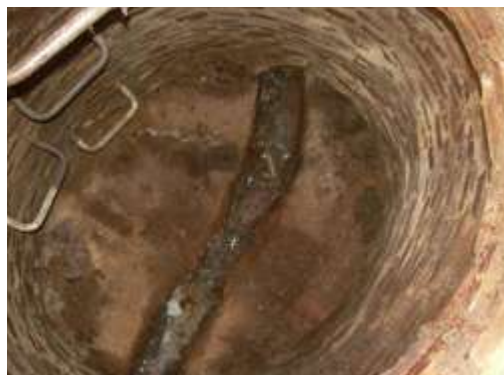
Top View

Evidence of surcharge - Bench debris.  
Channel debris.

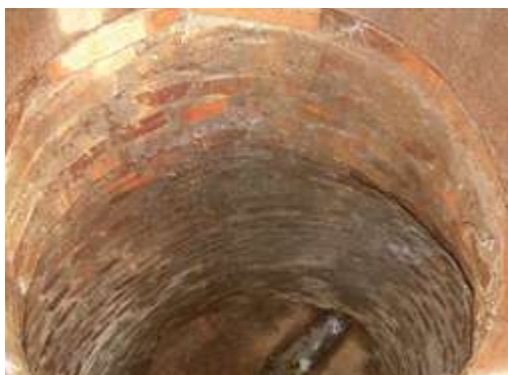
Defect

Condition: ☐ Sound ☐ Cracked ☒ **Leaks**

Condition: ☐ Sound ☐ Cracked ☐ Root Intrusion ☐ Loose Brick ☒ **Deteriorated**

Infiltration: ☐ None ☒ **Joint** ☐ Cracks ☐ Mortar ☐ Roots ☒ **Wall**

Frame leaks. Adjustment deterioration  
and infiltration. Corbel and Barrel  
infiltration.

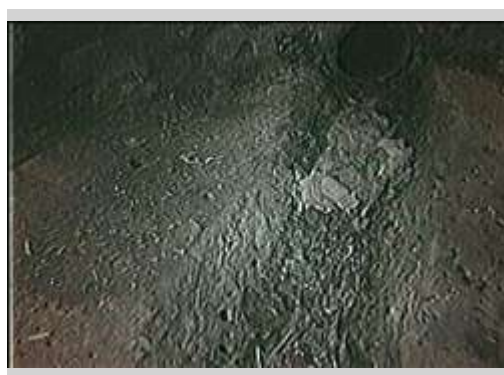
Defect

Channel debris.

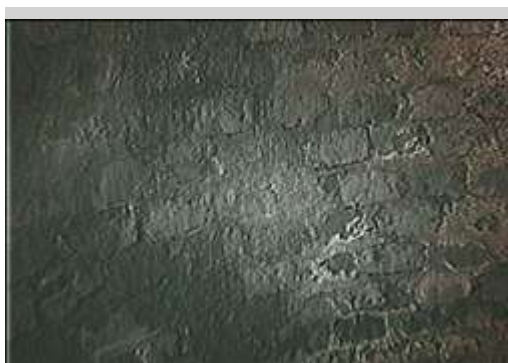
Defect

Condition: ☐ Sound ☐ Cracked ☐ Root Intrusion ☐ Loose Brick ☒ **Deteriorated**

Infiltration: ☐ None ☐ Joint ☐ Cracks ☒ **Mortar** ☐ Roots ☒ **Wall**

Barrel deterioration and infiltration.

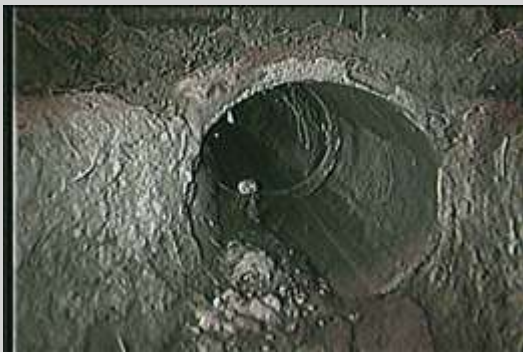
### 8 in. Circular Gravity Sewer Pipe Out @ 12 O'Clock

Deposits: ☐ None ☒ **Mud** ☐ Sludge ☒ **Debris** ☐ Grease

Silt Depth: **0.5** (in.) Deposits Extent: **Light**

Infiltration: **Evidence** Pipe Seal Cond: **Cracked**

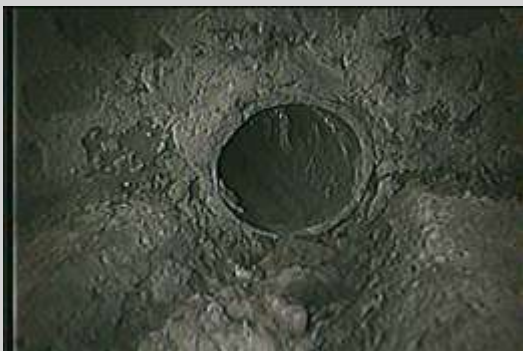
### 6 in. Circular Gravity Sewer Pipe In @ 7 O'Clock

Infiltration: **Evidence** Pipe Seal Cond: **Cracked**
